# U-6A / NU-1B Technical Support Contract

## Aircraft Inspection Report

December 19, 2003

Document Number: 2003 NU-1B 0001

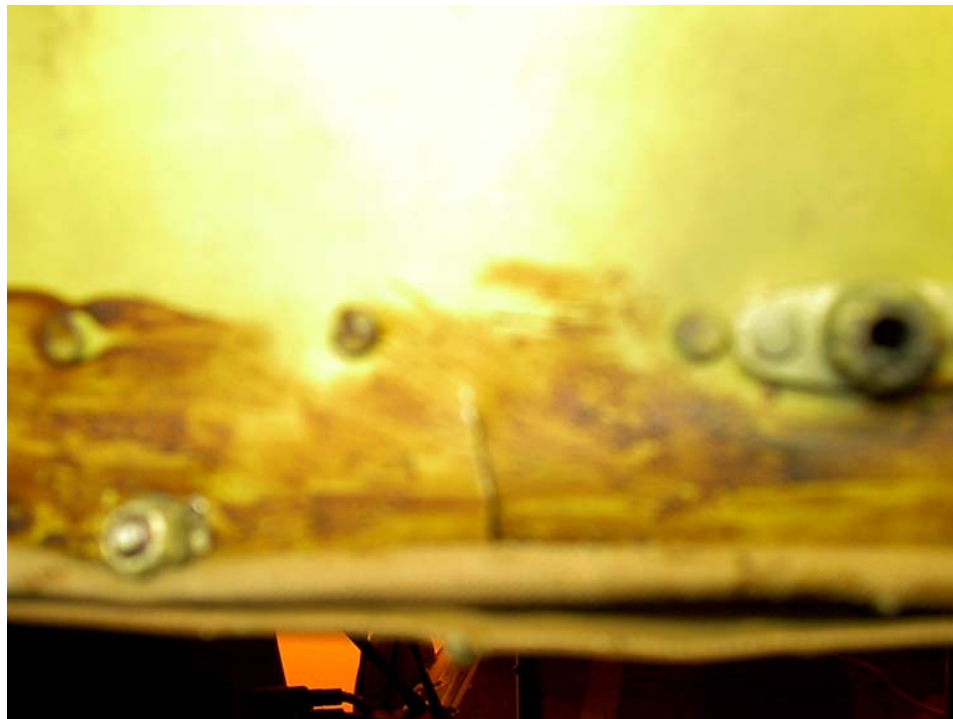
**5.4.3.26. Sheet metal damage inside rear bulkhead at station #308**

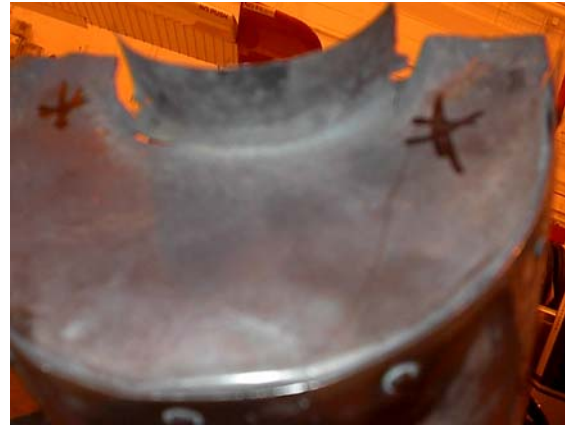
##### 5.4.4.1. **Many cracks, tears, etc. found on all heat muff baffles.**

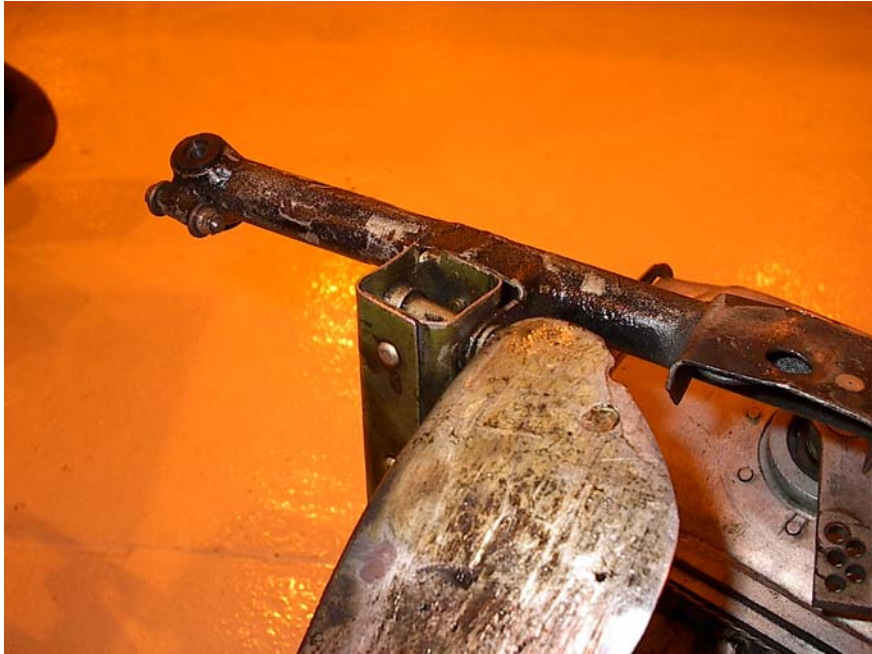
5.4.4.3. **1 crack found on Part # C3EC 38-7 – this part is located on carb heat selector door.**

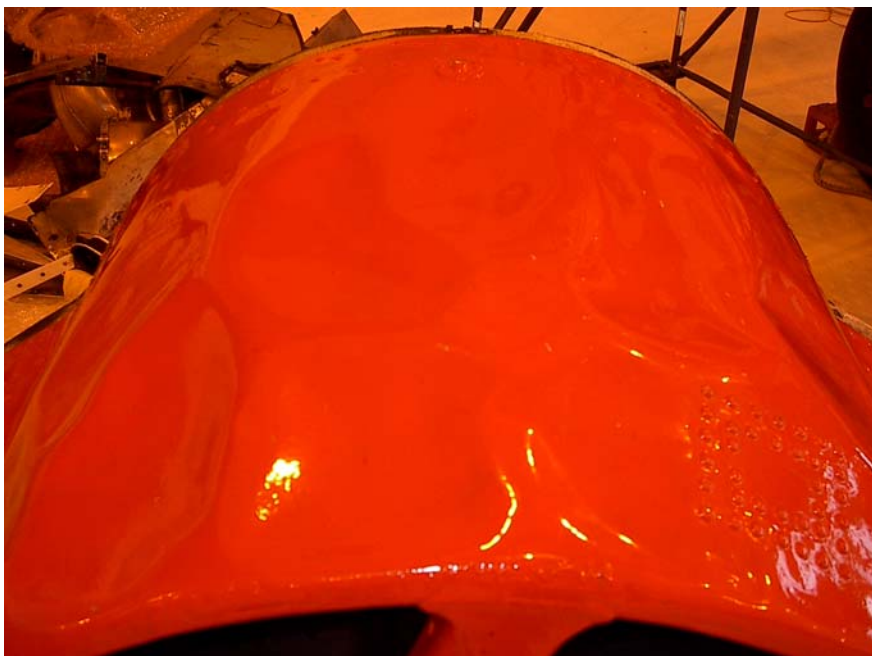
5.4.4.4. **Lower engine cowl air scoop fairing assy is badly oil canned**
